<b>AIRCRAFT ACCIDENT AND INCIDENT INVESTIGATION DEPARTMENT</b>
<b>INTERIM STATEMENT- ACCIDENT</b>

AAIID Ref No: ESW-AIG-ACCID-21-001

**Figure 1: Bell 206L1, V5-HOC.**

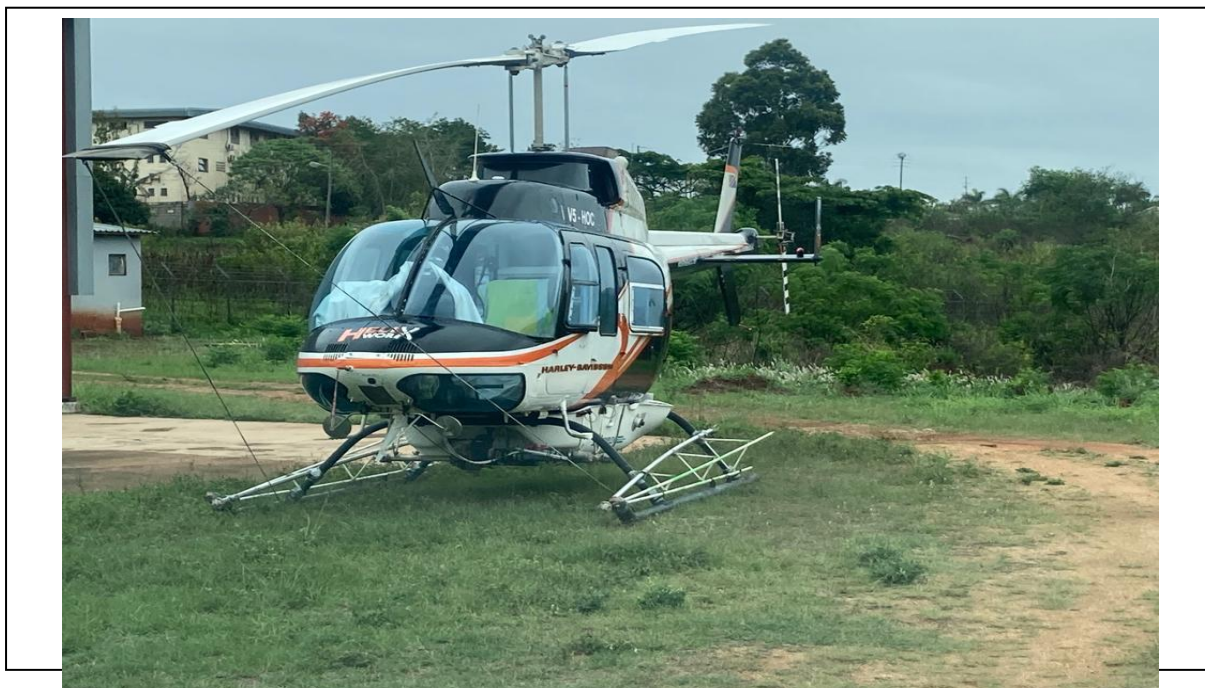
- The helicopter was fitted with a Simplex Model 7900 crop spraying tank and booms (Figure 1). Supplementary Type Certificate endorsement status for this modification could not be established at this stage.
