AIRCRAFT ACCIDENT AND INCIDENT INVESTIGATION DEPARTMENT
INTERIM STATEMENT- ACCIDENT

AAIID Ref No: ESW-AIG-ACCID-23-001

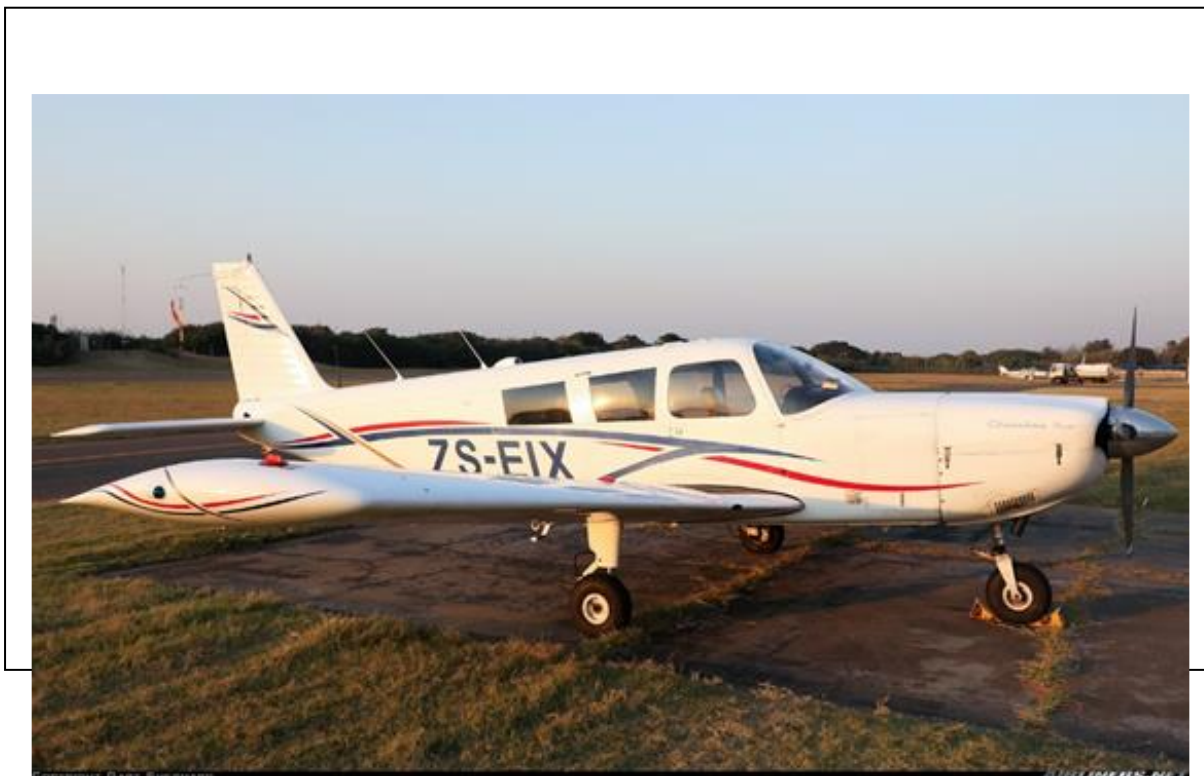
The aircraft came in contact with tree stumps, losing the left main landing gear and impacted the ground nose first then fell flat facing west. Smoke and small flames ensued from the engine. The pilot switched all systems off and they evacuated the aircraft through the starboard side door.

The flames spread and engulfed the entire fuselage, and the aircraft was destroyed.
